Hurricane Kate

November 15-23, 1985

Department of Natural Resources
Division of Beaches and Shores
Post Storm Report No. 86-1
September, 1986
By Ralph Clark

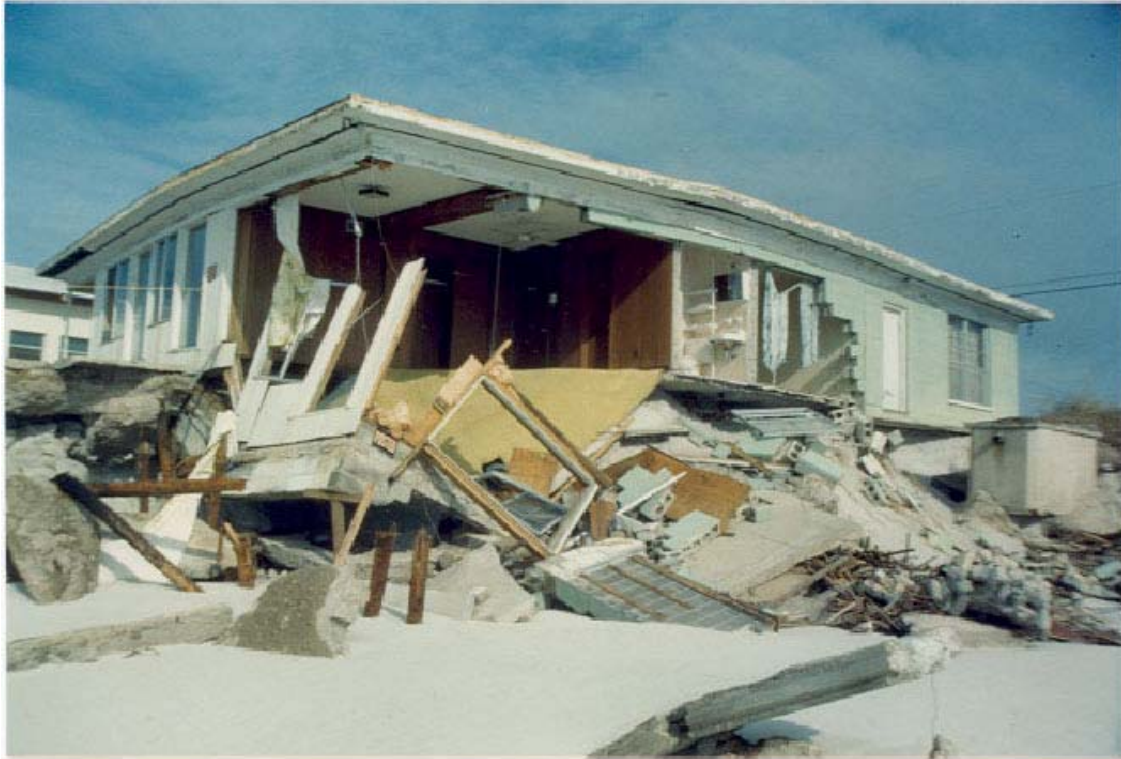
FIGURE 9. Slab-on-grade dwelling partly destroyed, Panama City Beach.

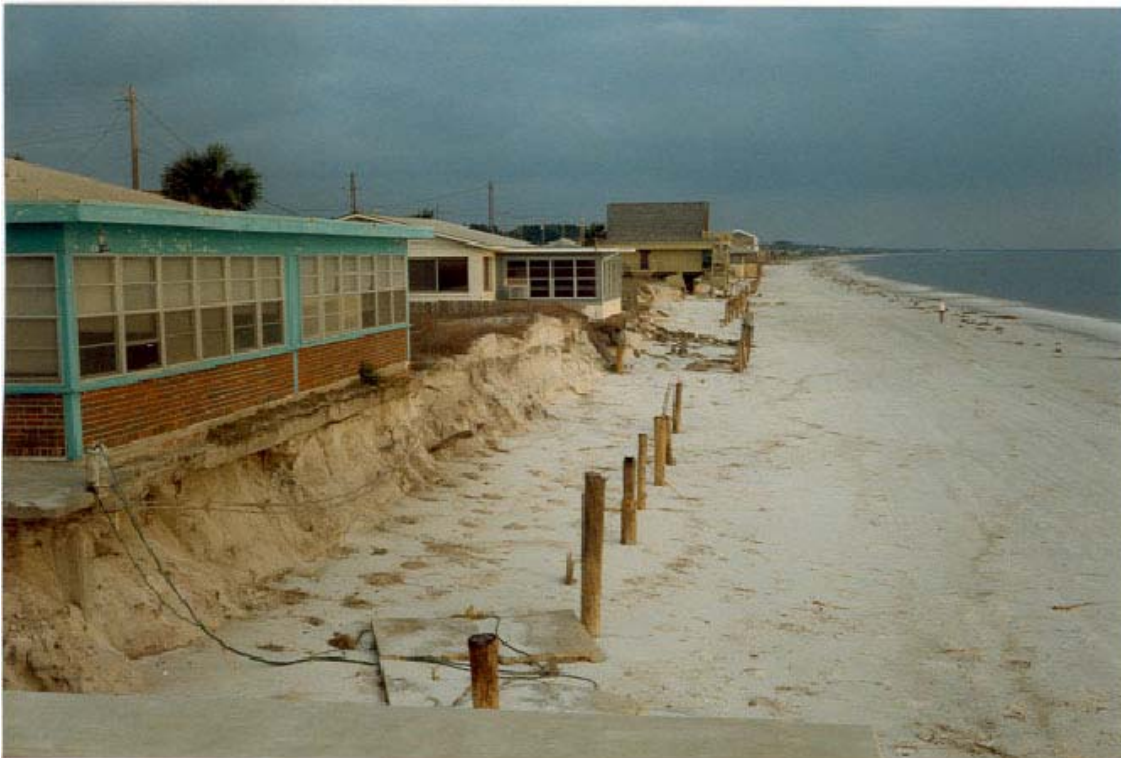
FIGURE 10. Mexico Beach Dwellings Threatened by dune erosion (Brett D. Moore)

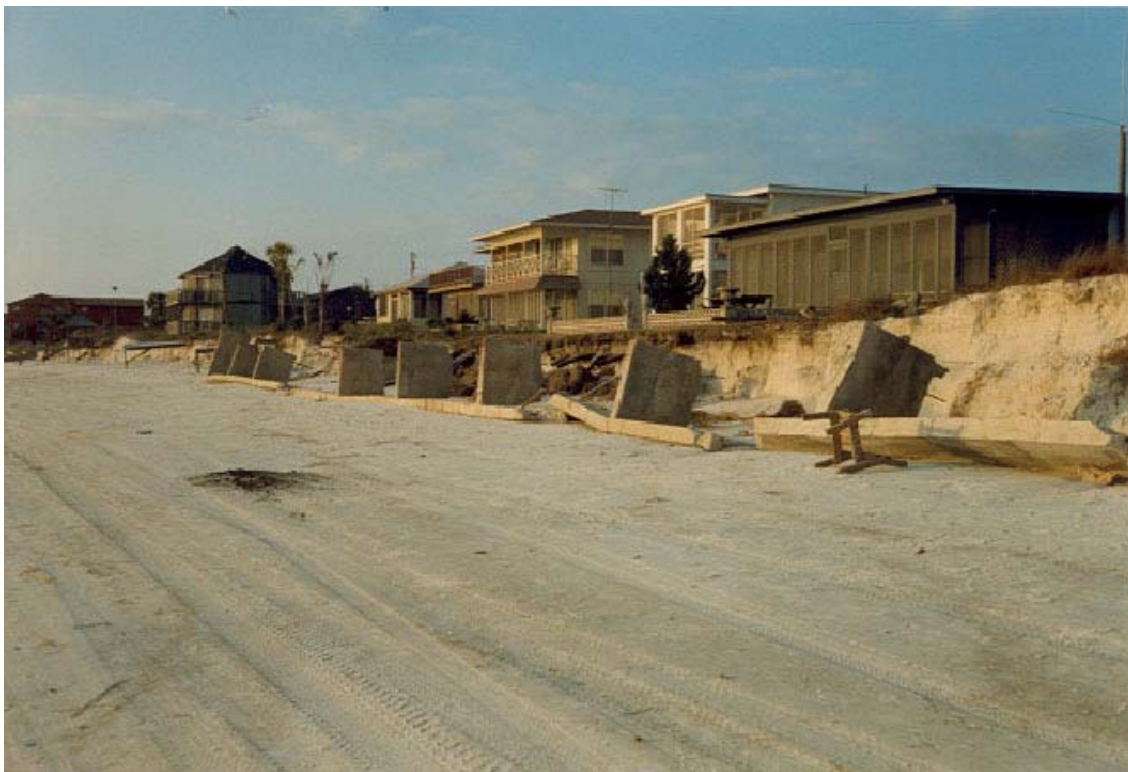
Adjacent 27th Street, 35 feet of concrete block wall was destroyed. Between 20th Street and 19th Street, 250 feet of concrete wall was undermined and destroyed (Figure 11). Another 75 feet of concrete block retaining wall and the front room of a slab-on-grade single-family dwelling was destroyed between 14th Street and 13th Street (Figure 12). To the west of 14th Street, a wood pile-supported dwelling was undermined and leaning from foundation settlement. At 13th Street, 35 feet of wooden bulkhead was damaged and 300 feet east of 12th Street, 75 feet of sloping concrete wall was substantially damaged. About 500 feet east of 12th Street, 60 feet of concrete block wall was destroyed at the Buena Vista Motel.

FIGURE 11. Concrete wall destroyed, Mexico Beach (Brett D. Moore).

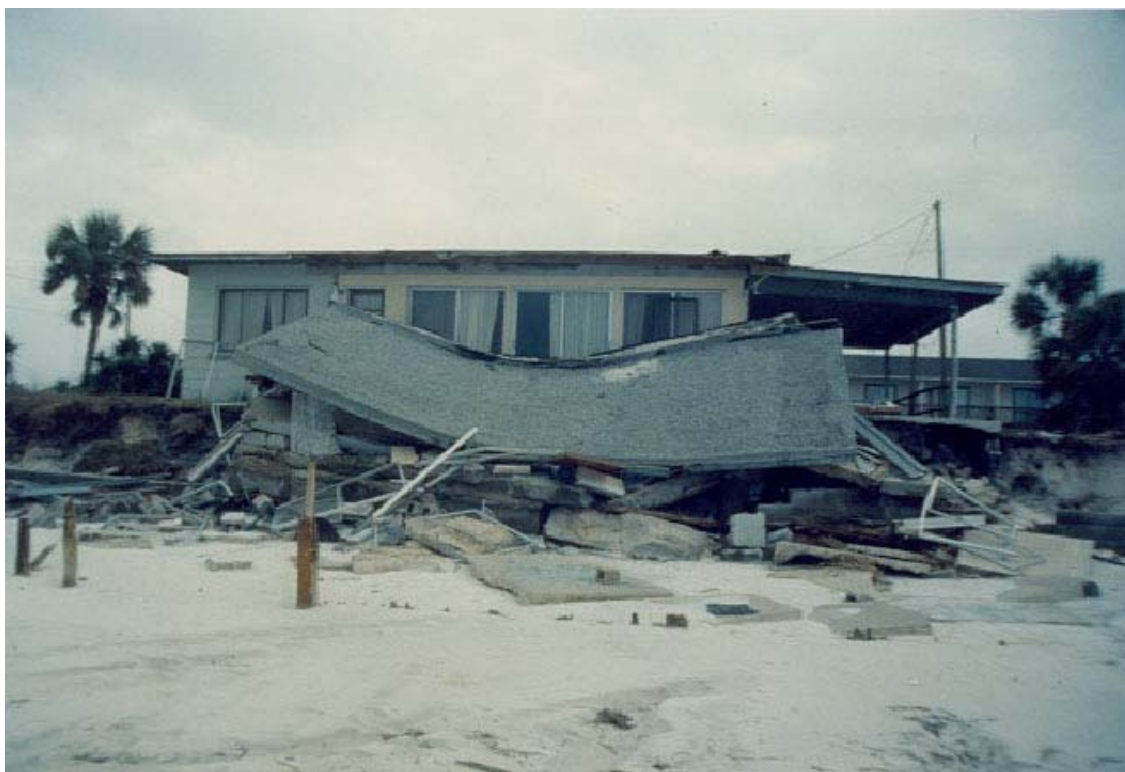
FIGURE 12. Seaward room destroyed on Mexico Beach dwelling.

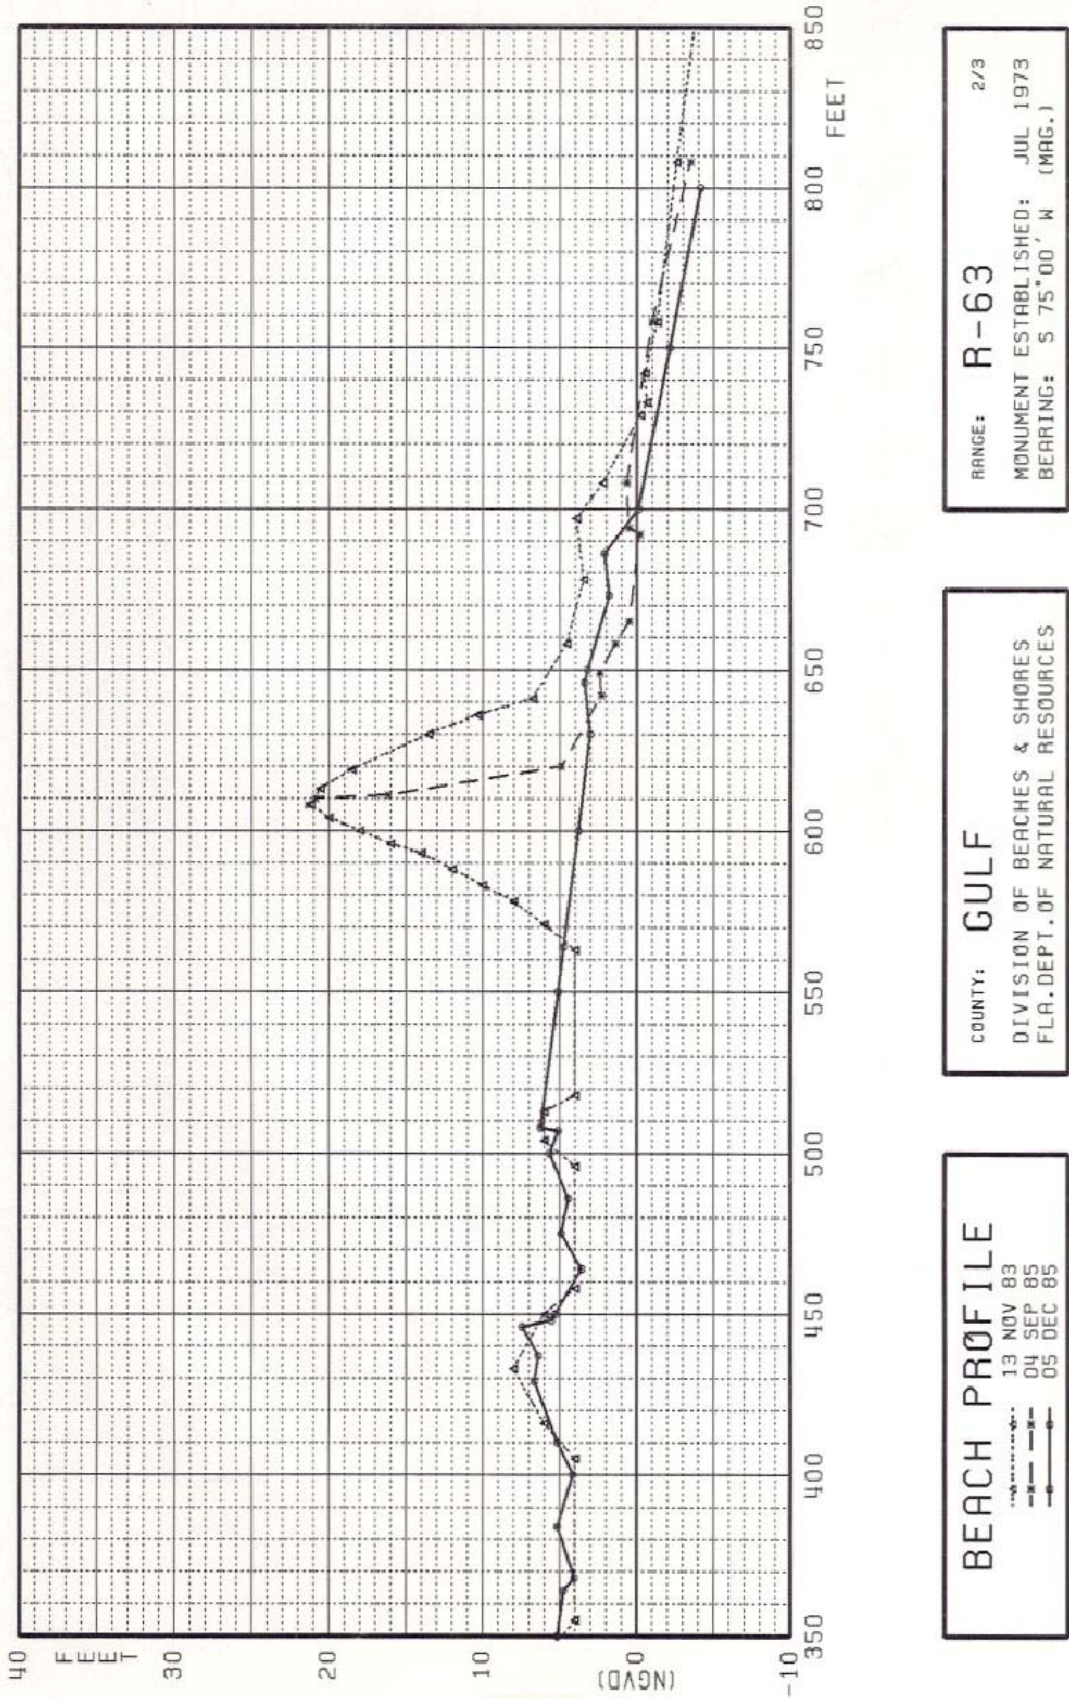
FIGURE 15. After hurricane Elena the seaward half of the barrier dune. Kate destroyed the remainder

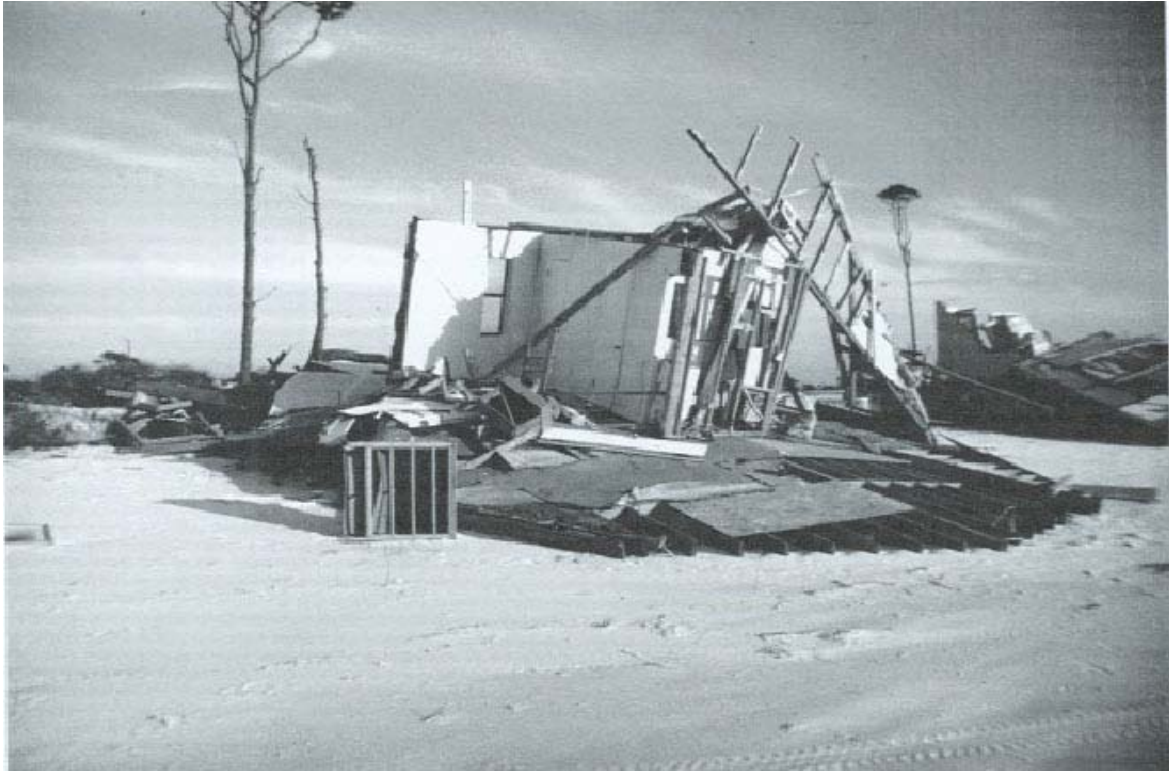
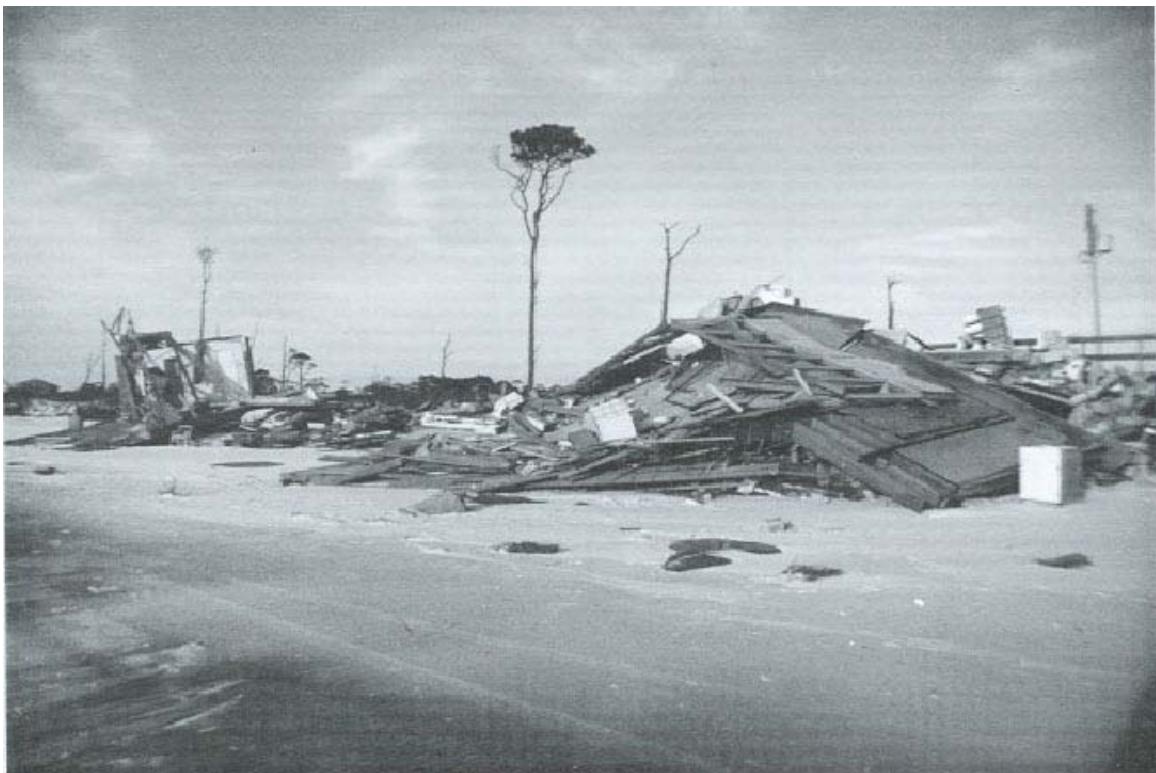
Midway between Cape San Blas and the State Park two single-family dwellings were totally destroyed by erosion, flooding and wave loads (Figures 16 and 17). Approximately 2,000 feet to the south, an inappropriately sited swimming pool was also destroyed. As recently as November, 1983, aerial photography showed these dwellings to be located about 40 feet landward of the beach and the pool to be located about 70 feet from the beach. Profile data obtained by the Bureau of Coastal Data Acquisition adjacent to these dwellings before and after Kate reflected horizontal dune recession of approximately 35 feet due to Kate and a total of 80 feet since November, 1983. A nearby house aligned with the destroyed houses was relocated by house moving equipment inland about 150 feet the day before hurricane Kate struck. This area extending southward to Cape San Blas has been experiencing substantial historical erosion with a shoreline recession rate estimated between 10 to 20 feet per year. At the curve of Gulf County Road C30E where it approaches the Gulf shoreline near Cape San Blas, the storm surge completely overtopped the road and the washover deposit was carried into St. Josephs Bay. This area is known as Stump Hole due to the numerous remnant pine tree stumps in the surf zone left as monuments to the erosion of past storms. This area previously experienced overwash during hurricane Agnes in 1972, but perhaps the most erosion in recent years occurred during the siege of El Nino storms in the winter and spring of 1983.

FIGURE 16. Dwelling destroyed, St. Joseph Peninsula.

FIGURE 17. Dwelling destroyed, St. Joseph Peninsula.

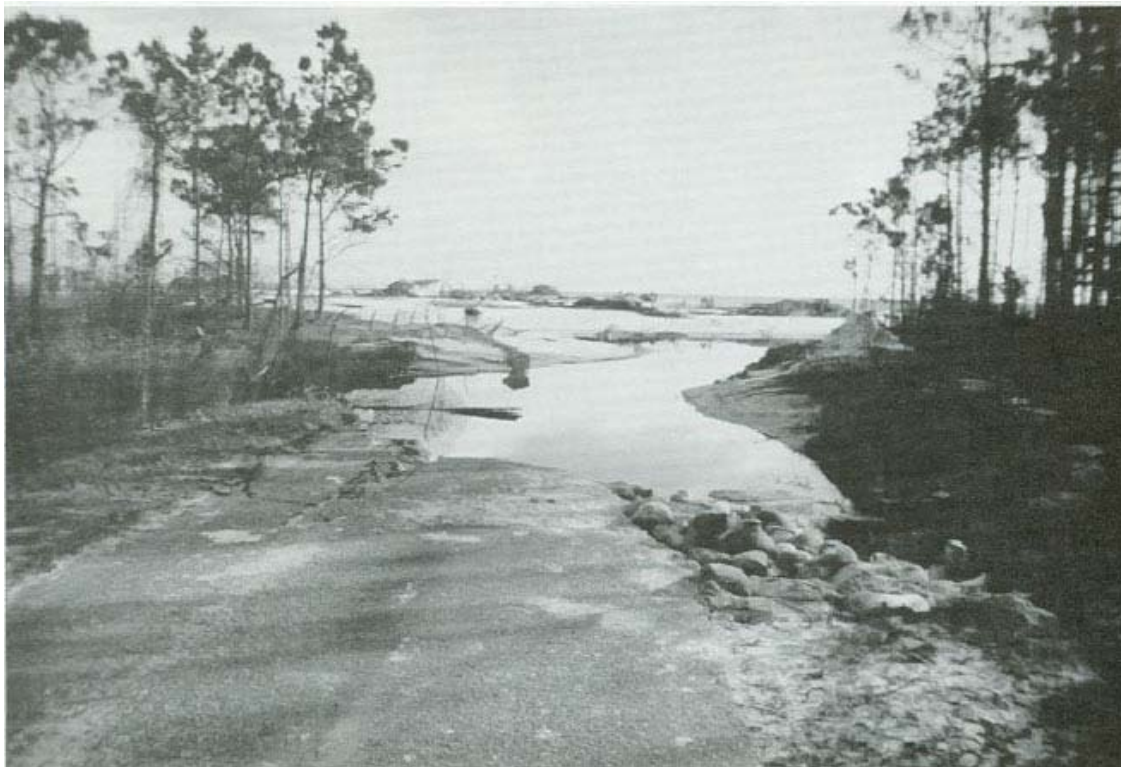
FIGURE 20. Cape San Blas beach access road destroyed.

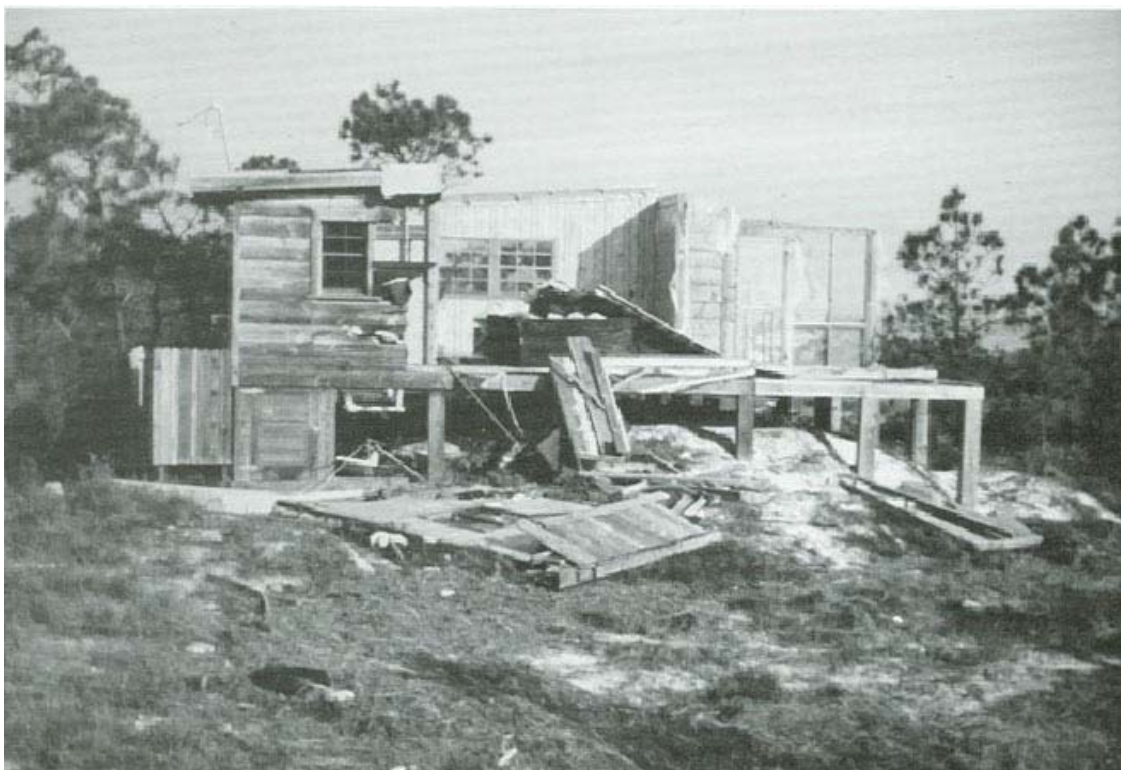
FIGURE 21. Dwelling by wind near Cape San Blas.

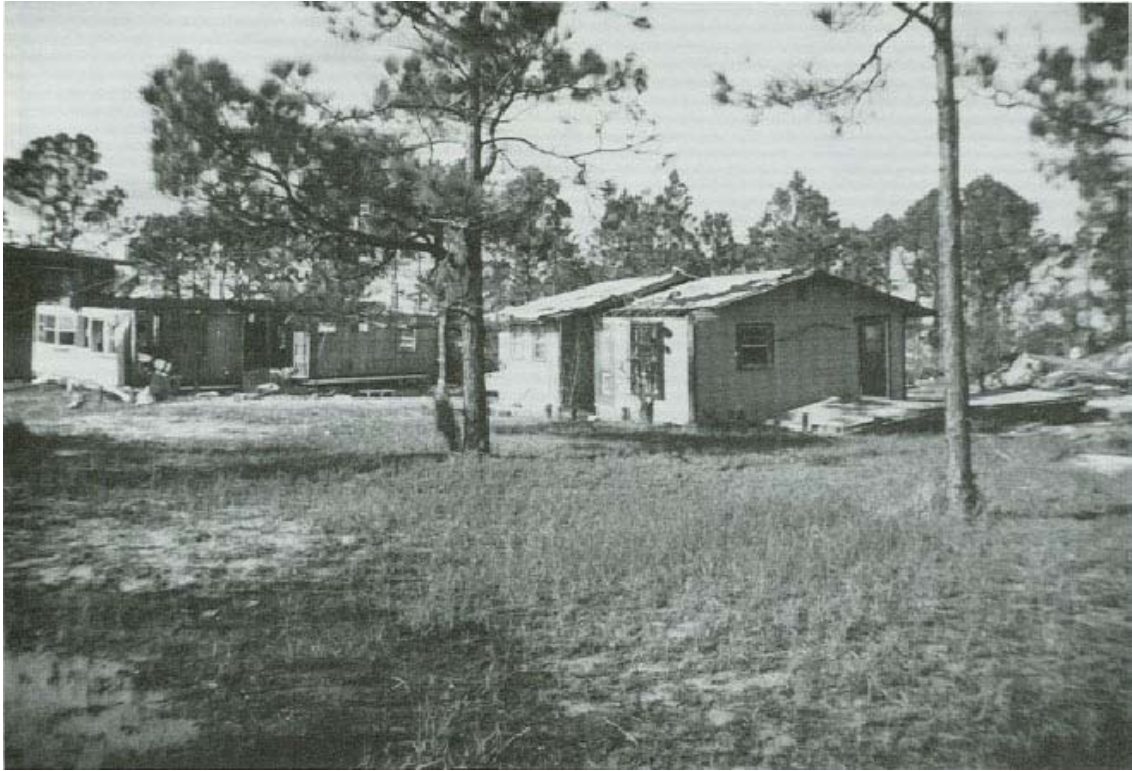
FIGURE 22. Flooded area east of Money Bayou.

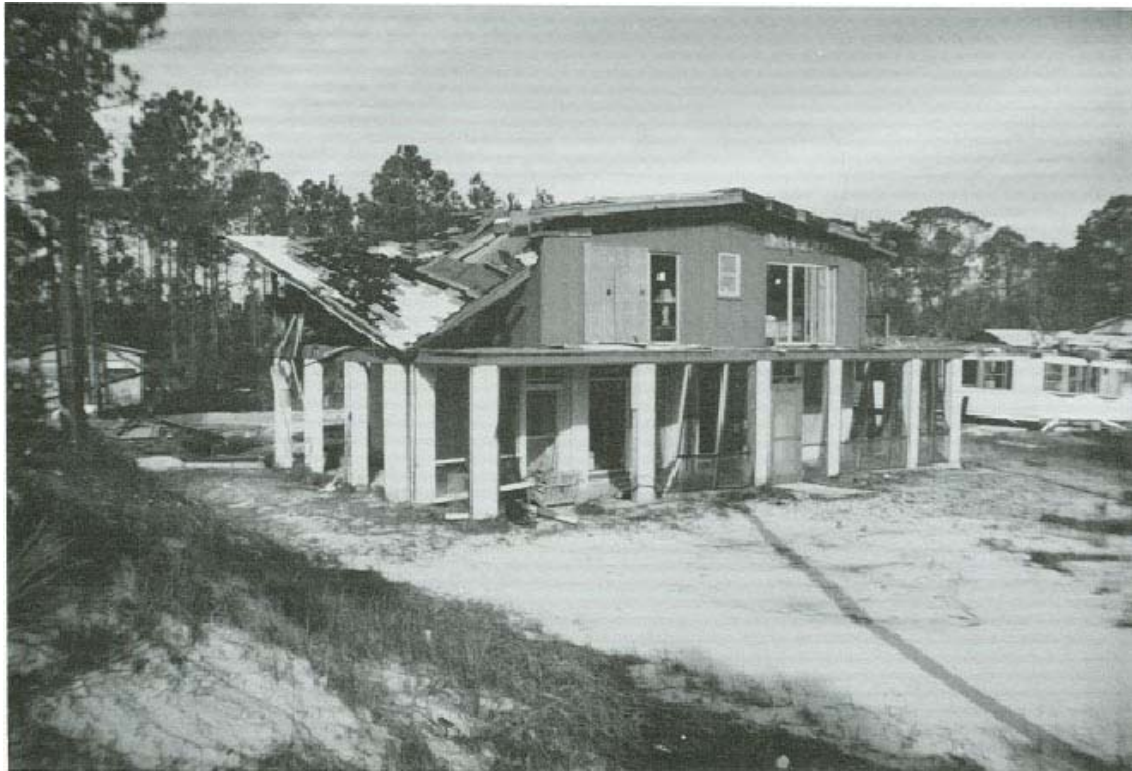
Money Bayou was opened to tidal flow by the storm surge of Kate. In this area the Coastal and Oceanographic Engineering Department, University of Florida, measured a high water mark of +8.4 feet NGVD. East of Money Bayou, extensive flooding and wind damage was sustained (Figure 22). The first dwelling east of Money Bayou, a two-story structure, sustained major flood damage to the ground floor and major roof collapse due to wind loads (Figure 23). The adjacent dwelling to the east, a manufactured

FIGURE 23. Dwelling damaged by wind and flooding.

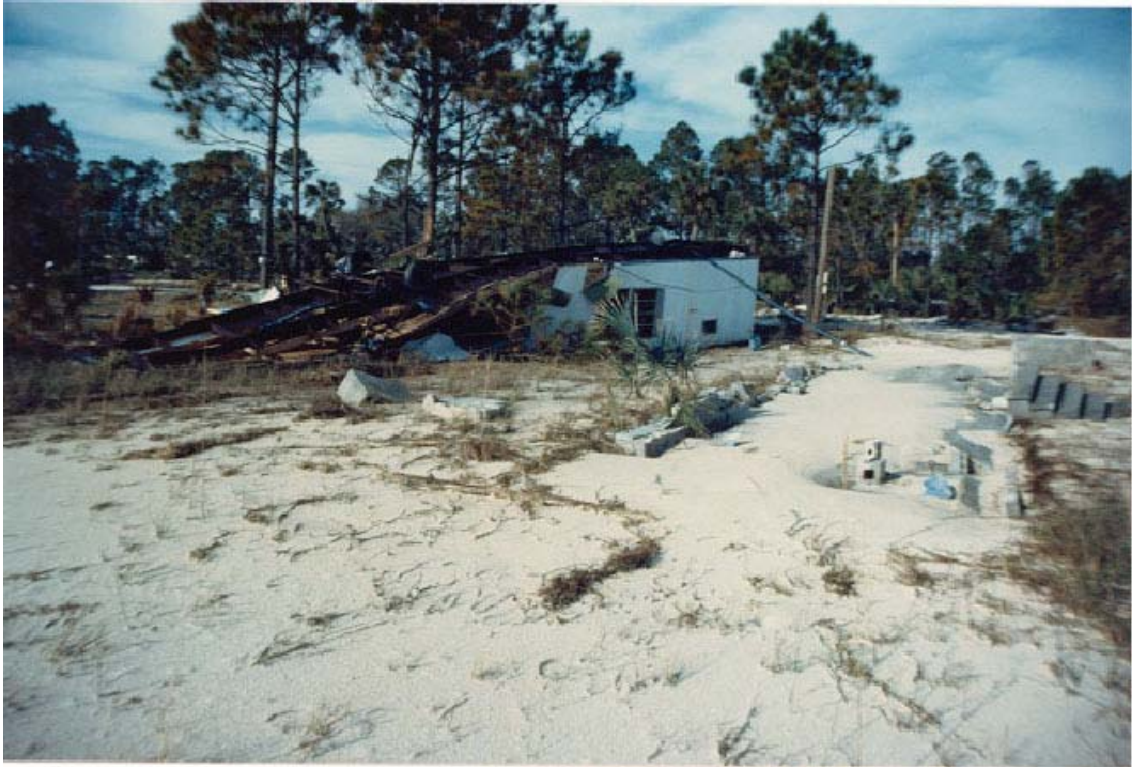
FIGURE 26. Mobile home destroyed by wind and flooding.

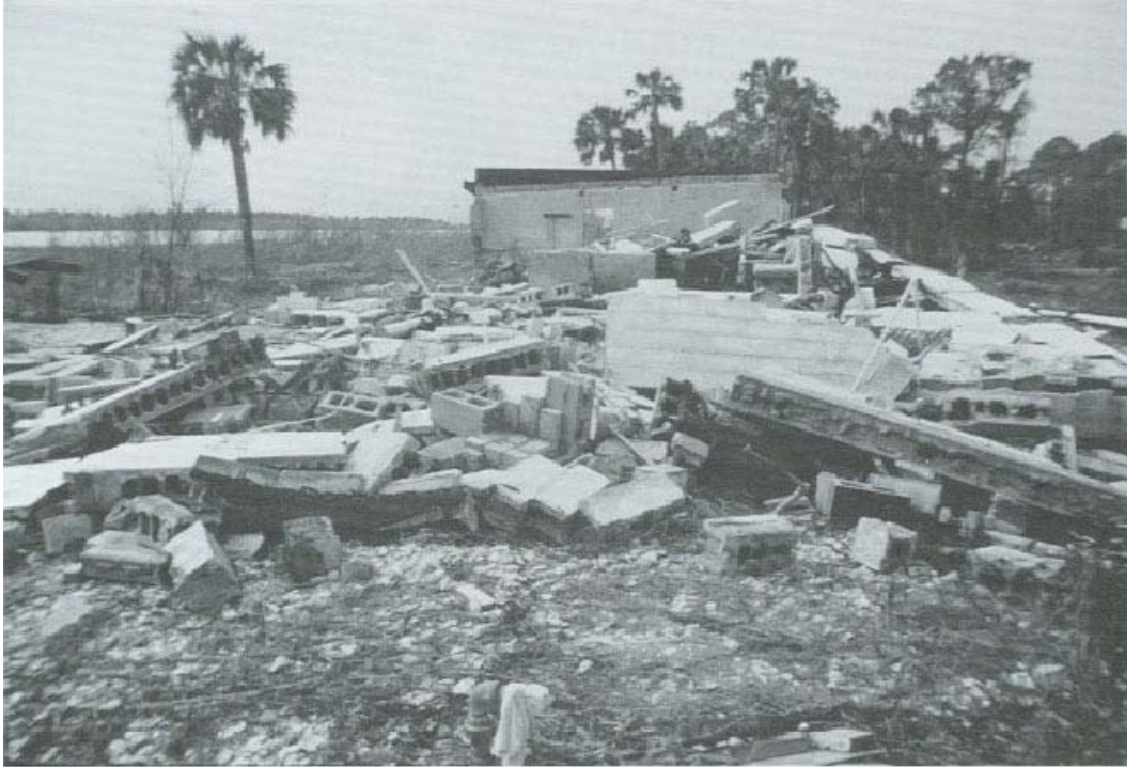
former seafood house which was being used as a storage building was totally destroyed by wave impact loads (Figure 30). Nearby, but only partially sheltered by the breakwater, another concrete block commercial building was damaged by waves and gutted by flooding (Figure 31). Across the street one mobile home was destroyed and another damaged by wind (Figure 32).

FIGURE 30. Concrete block commercial building destroyed by waves.

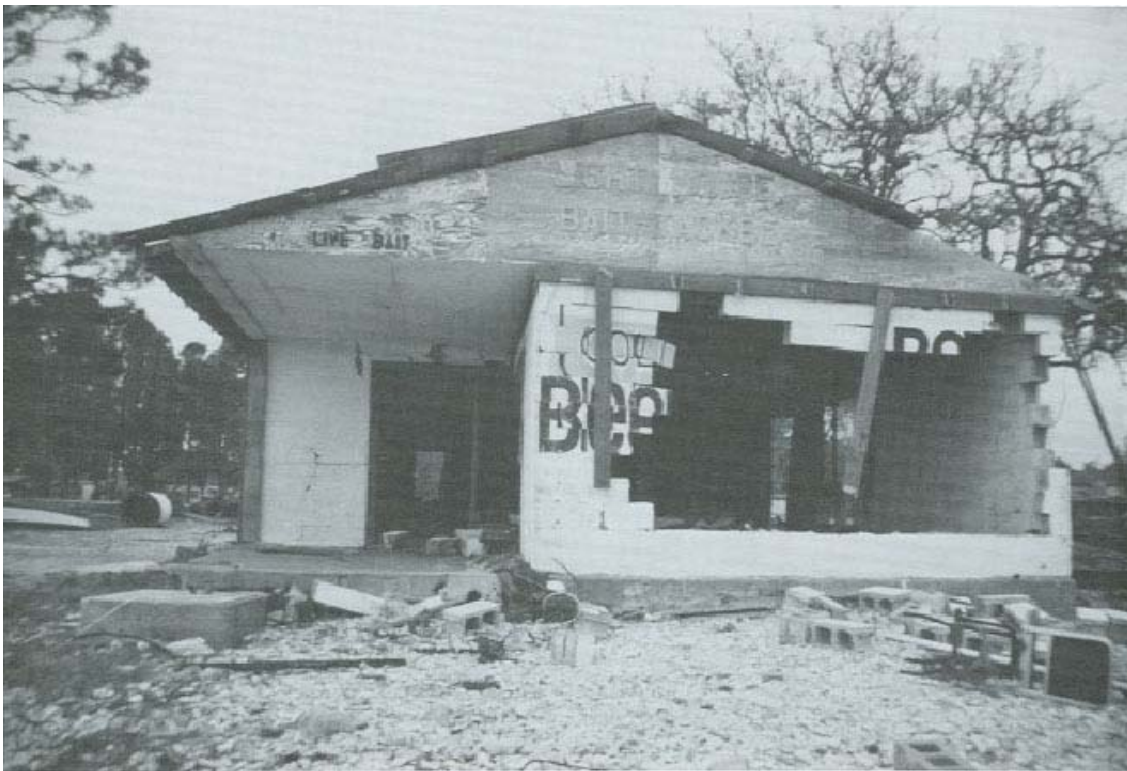
FIGURE 31. Heavy wave damage to another commercial building.

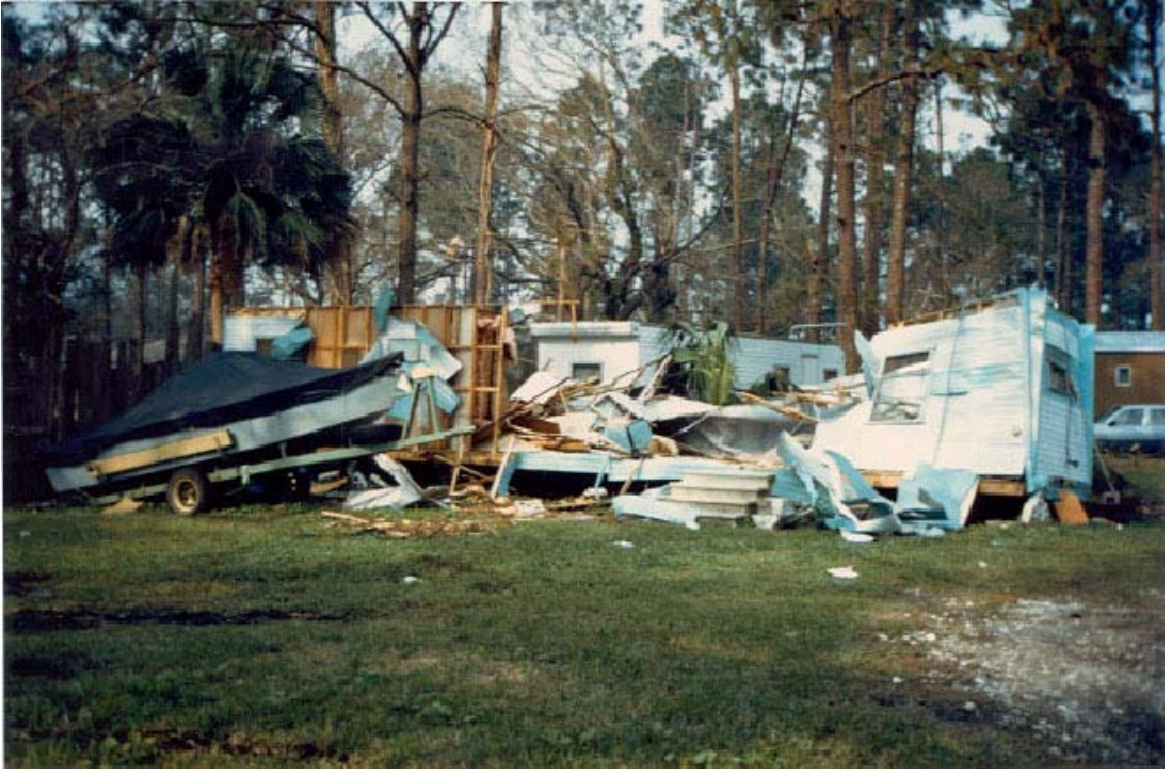
FIGURE 32. Mobile home destroyed by wind.

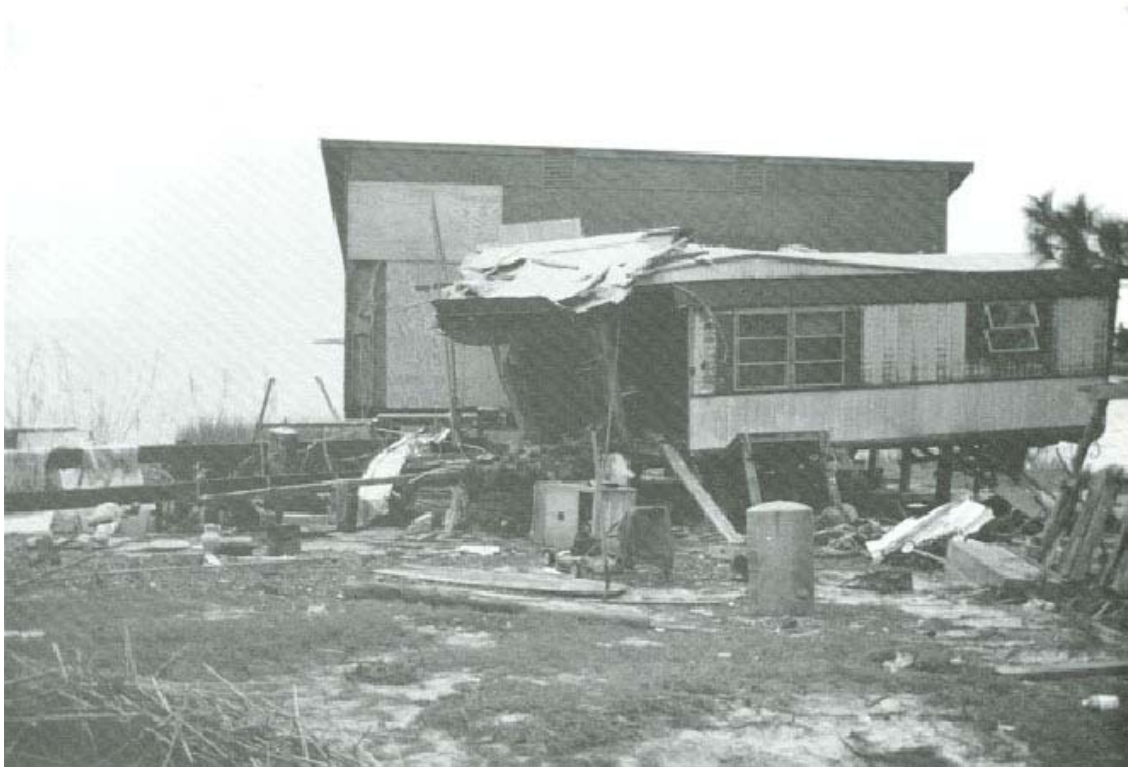
East of the navigation channel gap in the breakwater four major structures were destroyed and ten others were substantially damaged. One small mobile home was destroyed by flooding and another was destroyed by wind. Two other mobile homes were damaged by flooding, waves, and foundation scour. Three single family dwellings were substantially damaged by flooding, waves, and wind damage, one of which had its roof blown off and a detached bedroom damaged. Additionally, five seafood processing buildings sustained substantial wind and water damage. At the breakwater's east end the storm surge and storm waves broke over a bulkhead and destroyed a 50 foot segment of concrete block retaining wall and destroyed the eastern portion of the Hut Restaurant (Figure 33). Adjacent to the Hut Restaurant a mobile home was destroyed by waves and floating debris (Figure 34).

FIGURE 34. Apalachicola Bay shoreline dwelling destroyed.

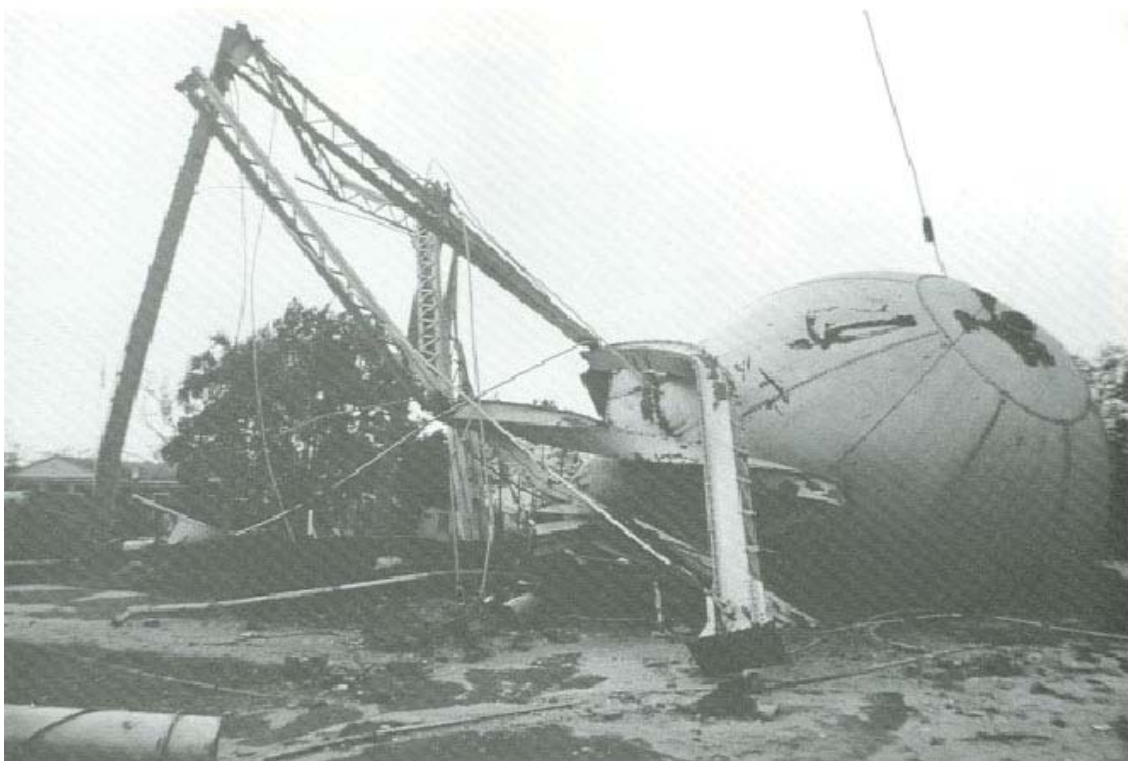
In downtown Apalachicola, the 100-year old water tower was toppled by Kate's winds (Figure 35). Widespread light wind damage was experienced throughout the city. One dwelling sustained major roof damage. Along the waterfront of the Apalachicola River, four seafood processing buildings and another metal commercial building sustained wind and water damage. Some dock damage and flooding was sustained along Water Street. At the mouth of the river a concrete block commercial building sustained heavy wave damage (Figure 36). Docks and boats alike were damaged at the marina at Battery Park (Figure 37). Nearby an old wood hotel structure sustained foundation damage due to wave activity.

FIGURE 35. One hundred year old Apalachicola water tower toppled by Kate's winds.

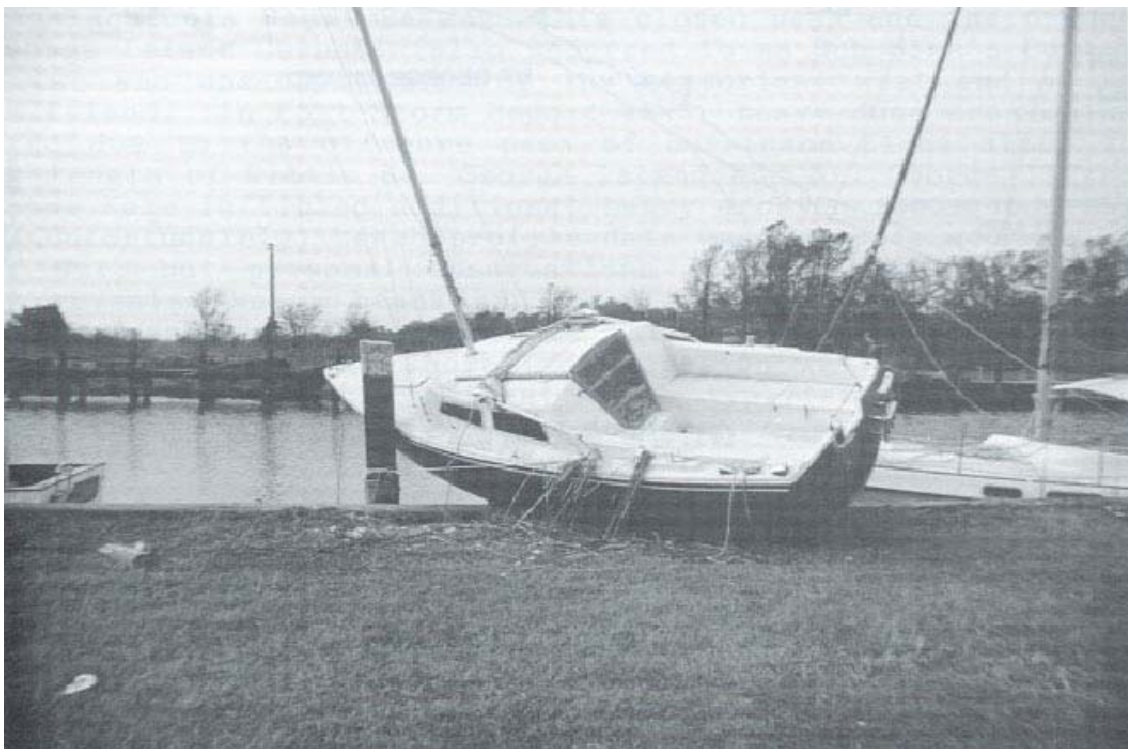
FIGURE 37. Marina Damage at Battery Park, Apalachicola.

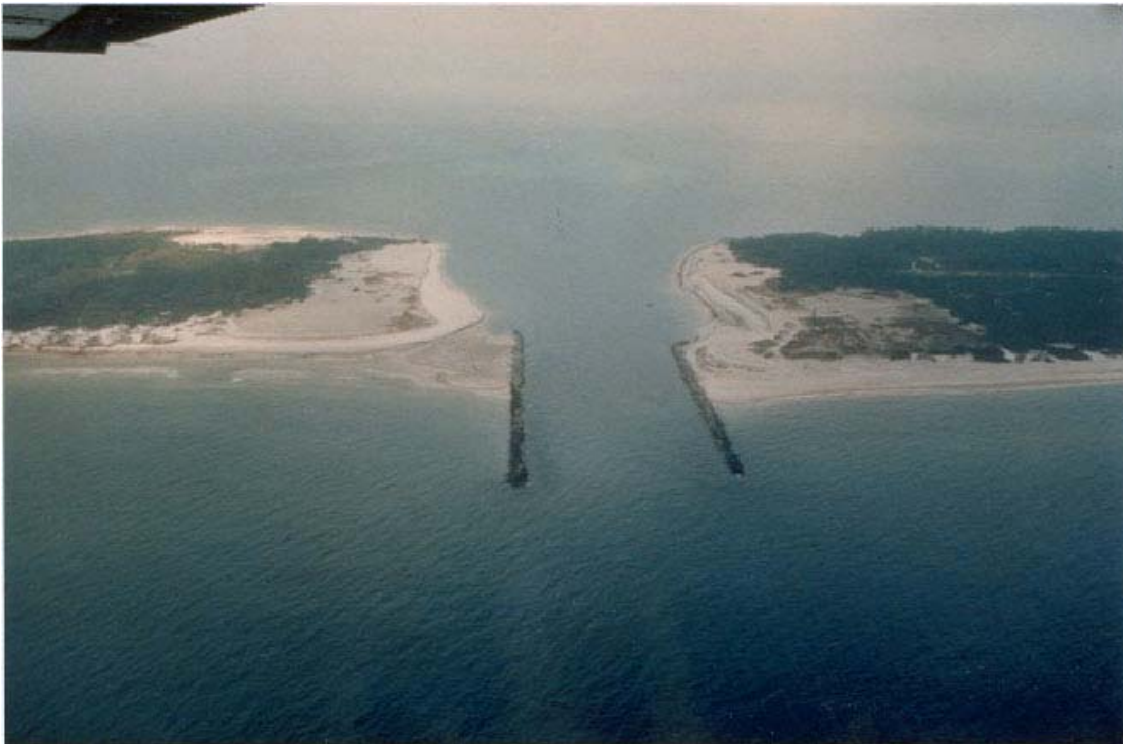
the inlet by Kate (Figure 40), conditions were substantially better than After Elena. The storm waves of Kate must have been substantially out of the southwest because the black channel buoy normally located directly offshore from the inlet was located one mile east of Sike's Cut after the storm.

FIGURE 40. Sike's cut after Kate, November 24, 1985 (Kevin R. Bodge).

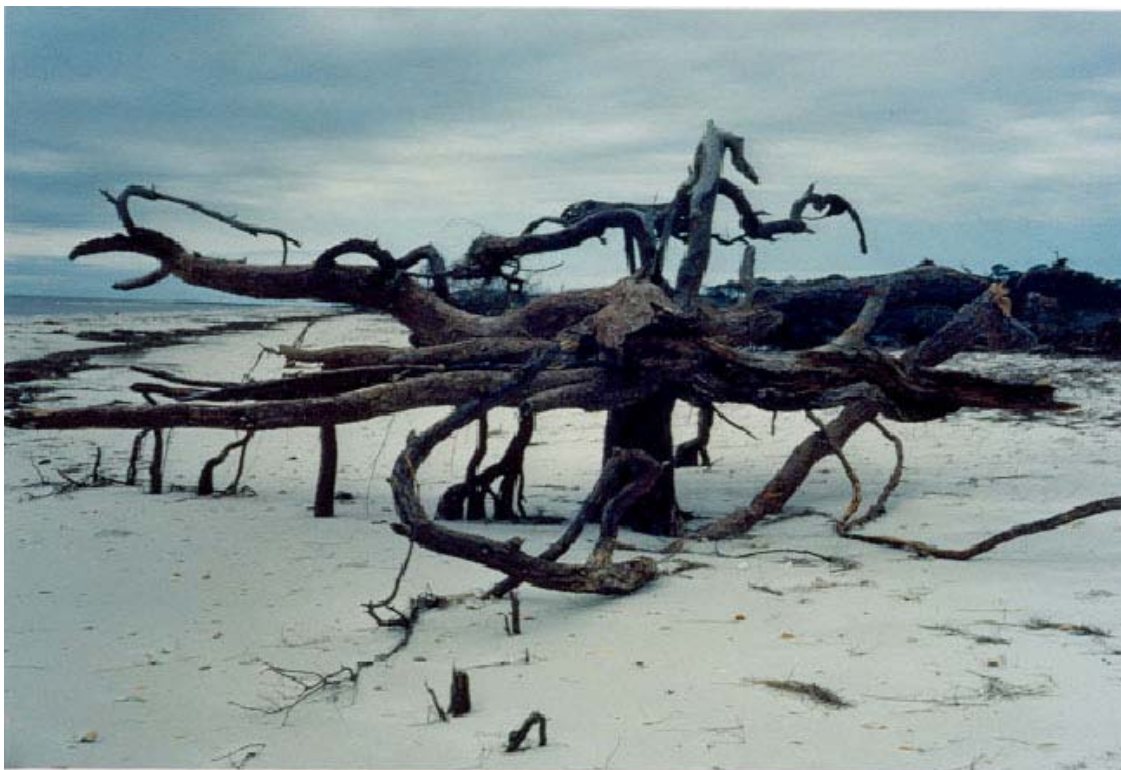
FIGURE 41. Sand pine stump on the beach reveals severe erosion. St. George Island Plantation.

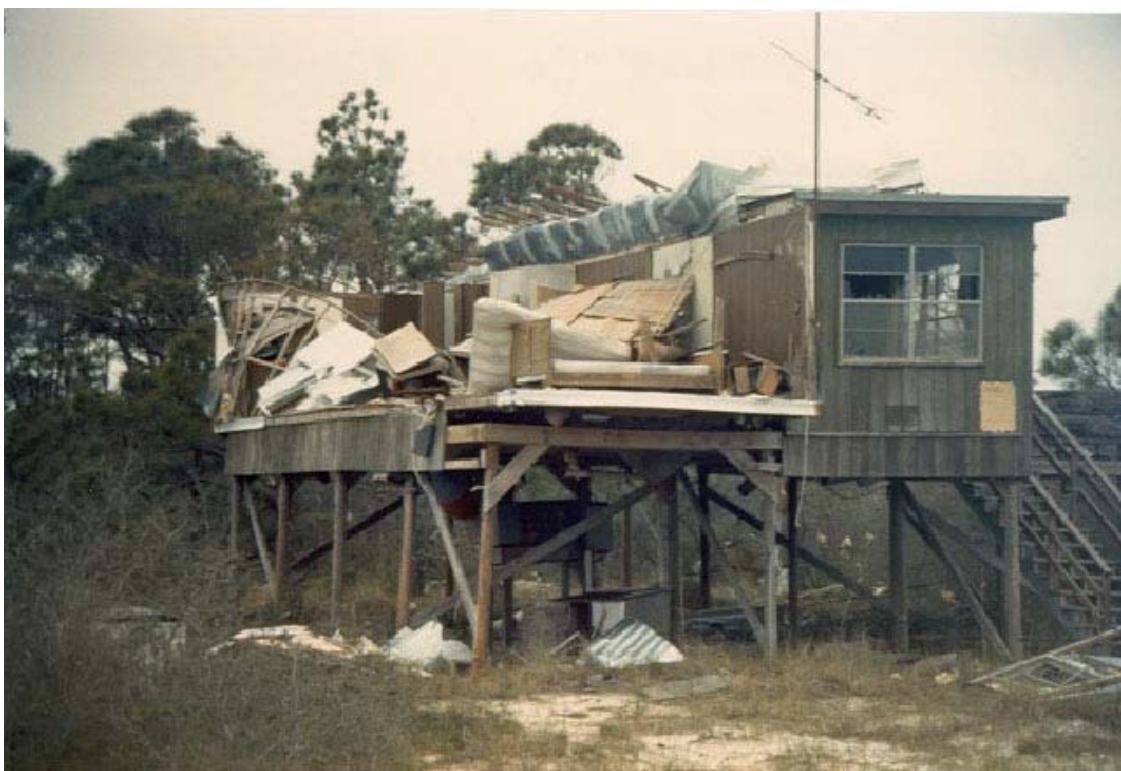
FIGURE 42. destroyed dwelling on Gulf Beach Drive.

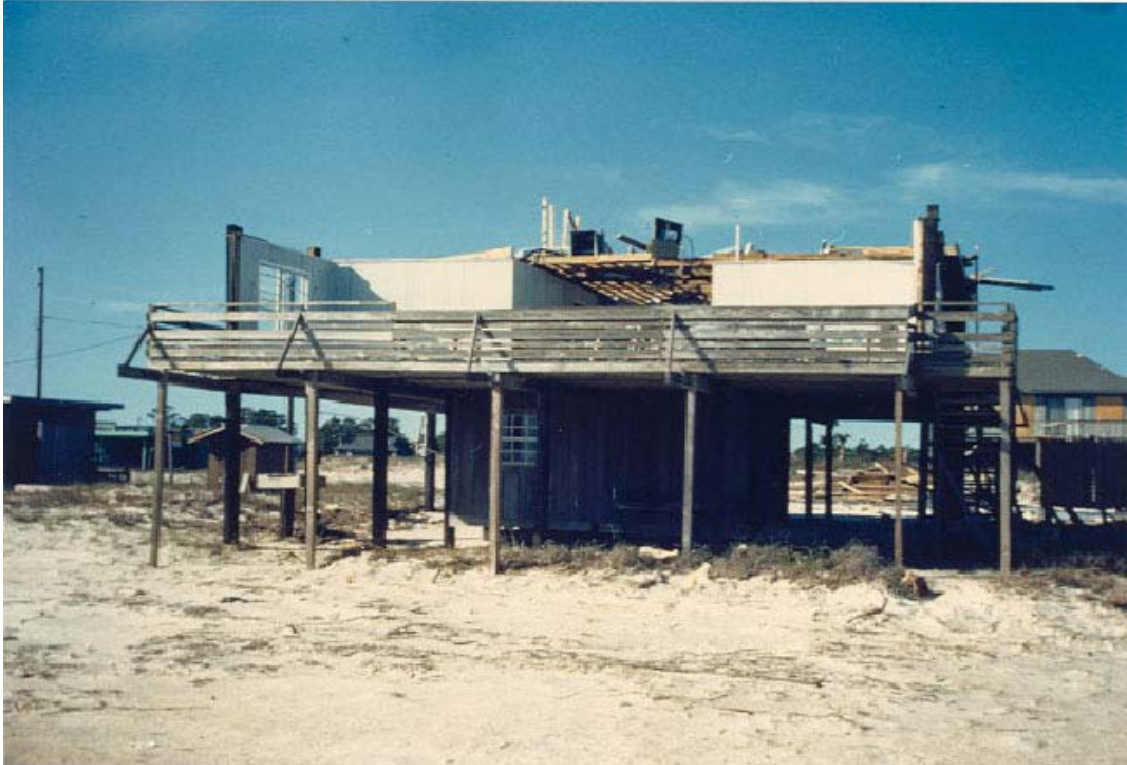
FIGURE 46. St. George Island beach Dwelling destroyed by wind.

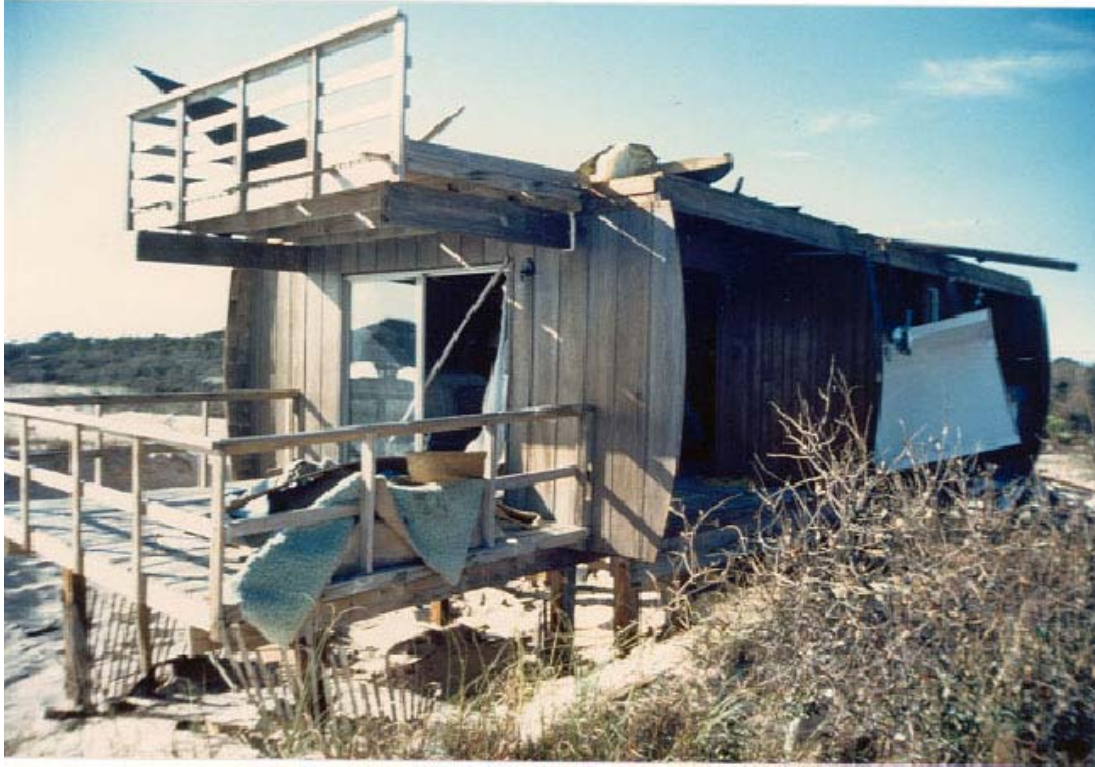
FIGURE 47. Barrel-shaped house destroyed by wind.
